NACA RM E54K23

AN EXPERIMENTAL EVALUATION OF SEVERAL DESIGN
VARIATIONS OF HOLLOW TURBINE BLADES FOR
EXPENDABLE ENGINE APPLICATION

By W. C. Morgan and R. H. Kemp

WASHINGTON
February 23, 1955

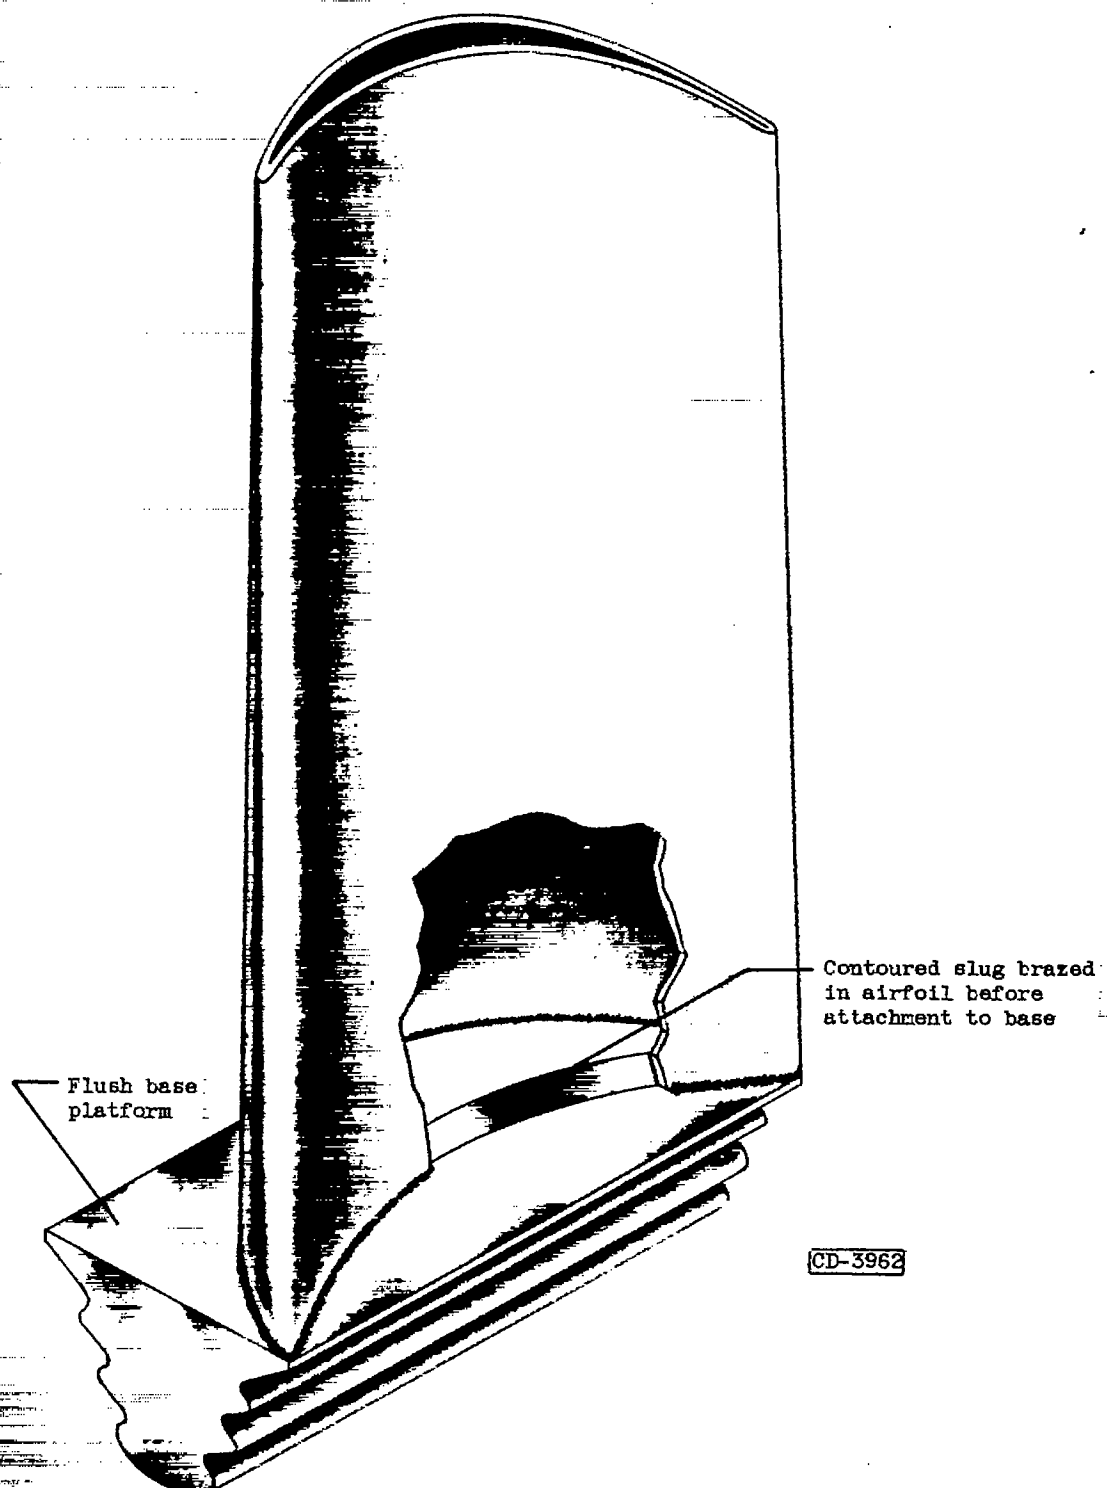
Figure 4. - Construction of sheet-metal airfoil brazed to flush base platform.

Group 7. - (L-605, 0.030-in. wall, welded airfoil brazed to flush platform as shown in fig. 4, fig. 3, base C.) The three specimen blades were intact at the end of 30 hours of operation. The results indicated that it would be practical to use a brazed joint in tension for the base attachment.

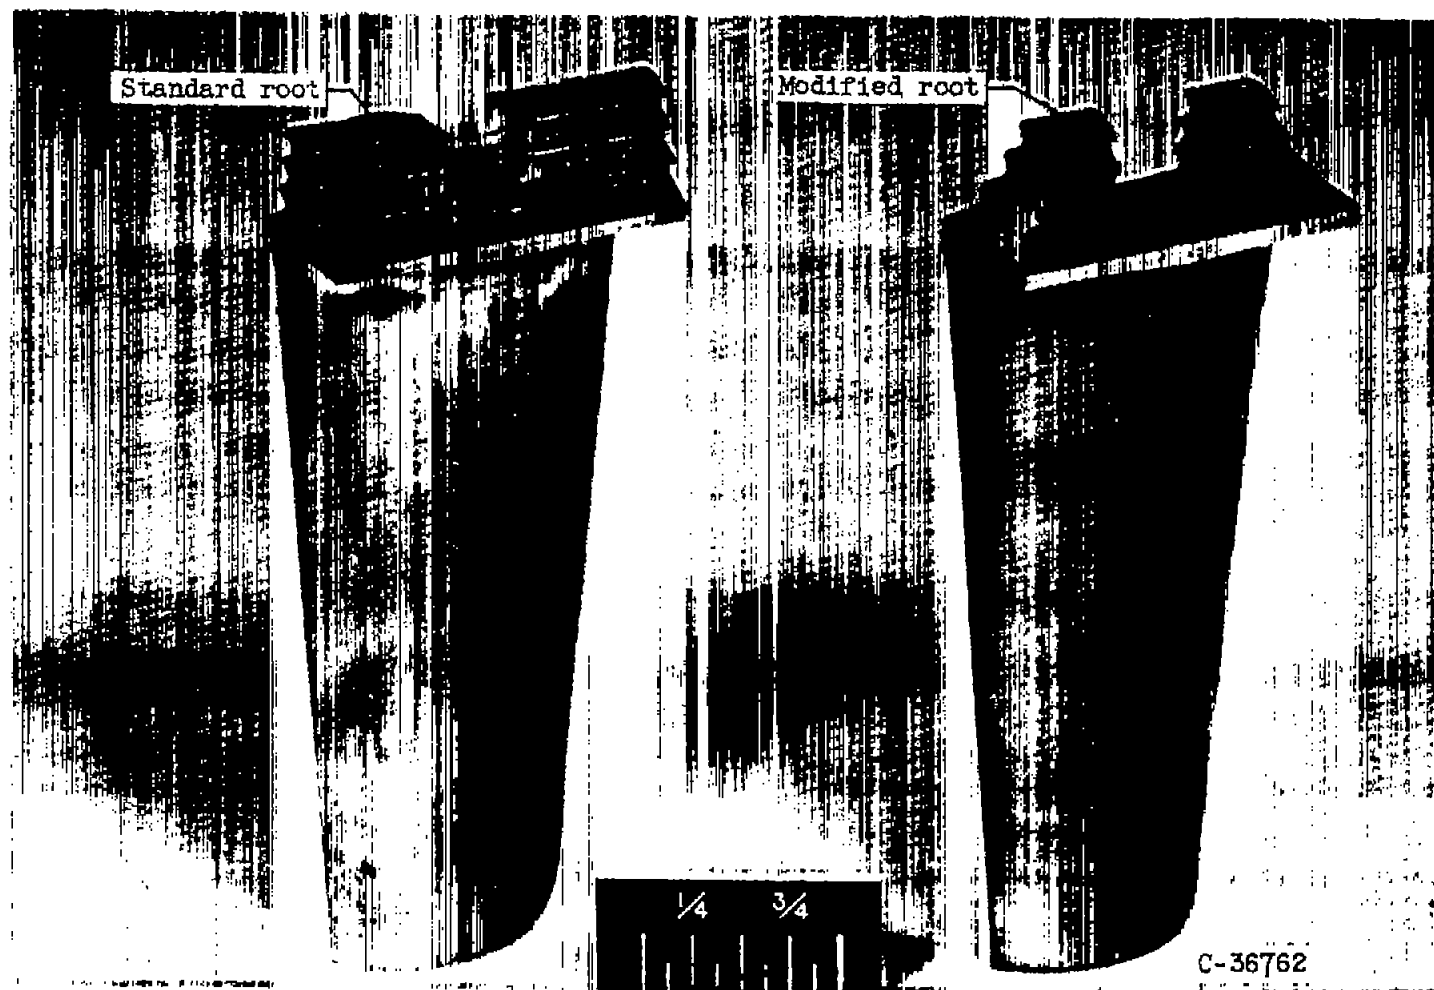
Figure 7. - Standard and modified root shapes of cast hollow turbine blades.

The root modification used for cast-blade specimens was found to be satisfactory as a means of blade retention and well adapted to a light-weight rotor installation. It was observed during inspection after engine operation, however, that incipient cracks were forming in the root serrations.

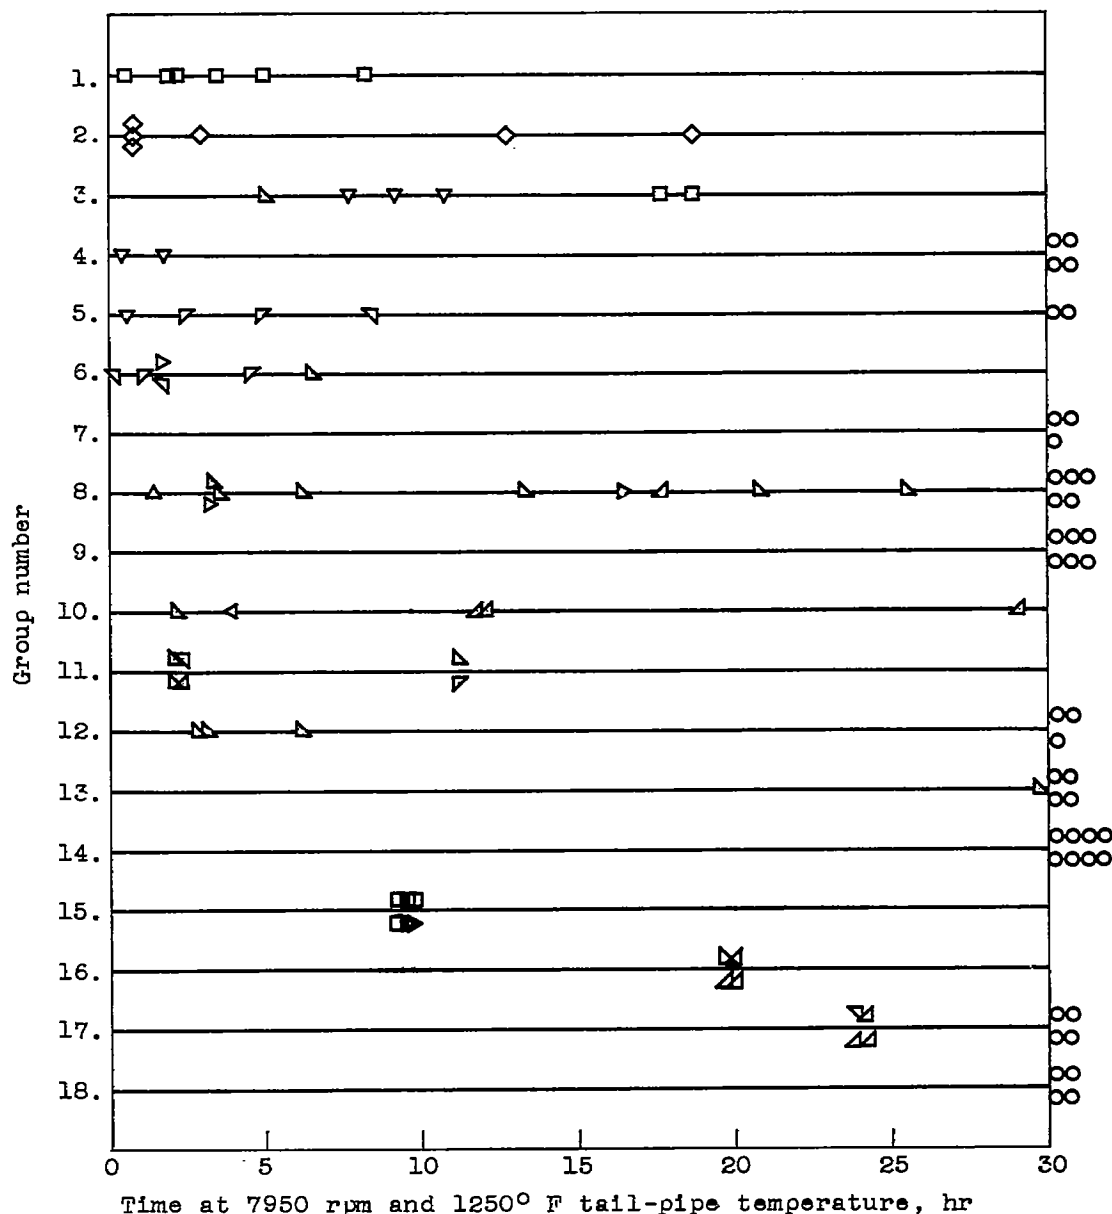
Figure 8. - Results of engine operation of 18 hollow-blade design variations.

The results of the investigation are presented in figure 8. The order of listing is not chronological in all cases.
